HUGHES TOOL COMPANY · AIRCRAFT DIVISION  
Culver City, California

Report 285-18 (62-18)

HOT CYCLE ROTOR SYSTEM  
MATERIALS & PROCESSES

March 1962

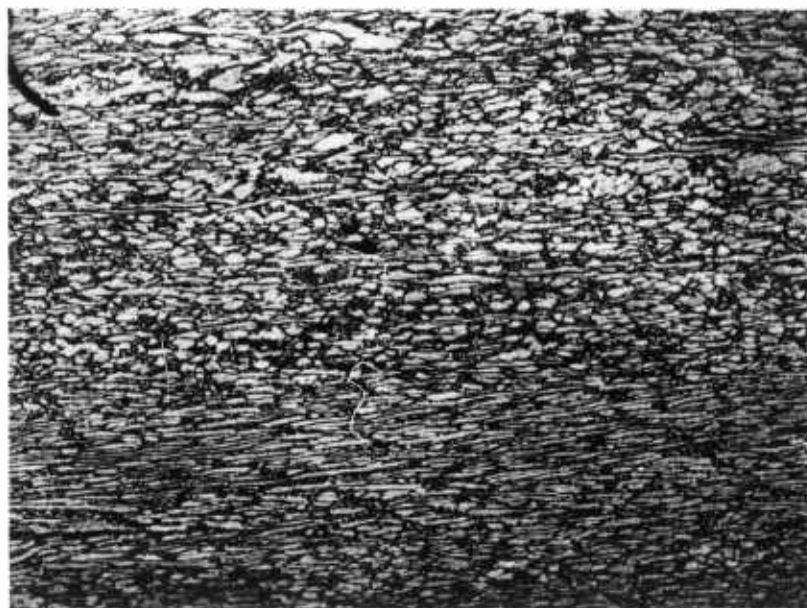
Figure 2.1-1. Photomicrograph of Spar Material

The material was annealed and warm rolled, and was used in that condition. Grain size was from 7 to 8 with normal alpha structure. A photomicrograph is given in Figure 2.1-1. Other static and fatigue properties are reported in Reference 1.

Titanium 6Al-4V  
Magnification 100x  
Normal Alpha Structure  
Grain Direction Longitudinal To Spar

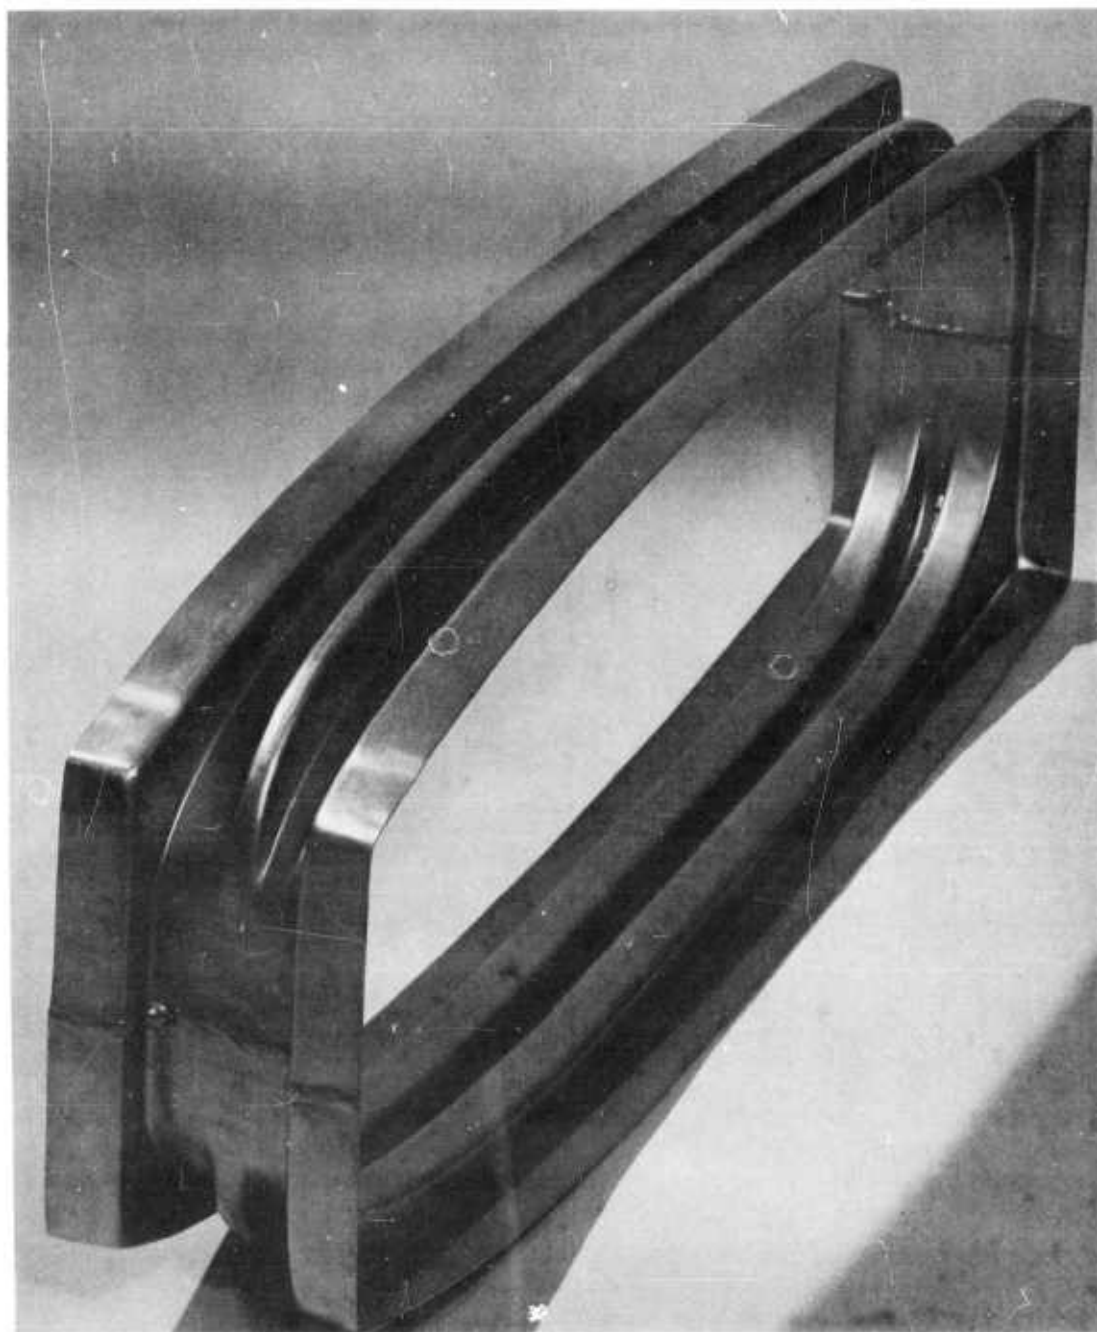
Figure 3.3-1. Preliminary Sample of Drop Hammered Inconel "X" Flexure

The flexible coupling is a complex cross section where flexibility is required in one direction and stiffness in the other. The part was made in two halves and joined at the chord plane, as shown in Figure 3.3-1, by fusion welding with the tungsten inert arc method using Inconel X filler. Parts were then placed in a fixture and tie straps resistance welded to the upper and lower sides of the sections. Before spotwelding the parts were liquid honed in the area where the welding was to be performed. In order that the surfaces to be welded would not be contaminated, marked pieces of platers tape were attached adjacent to the weld area and these were used to index the welds.

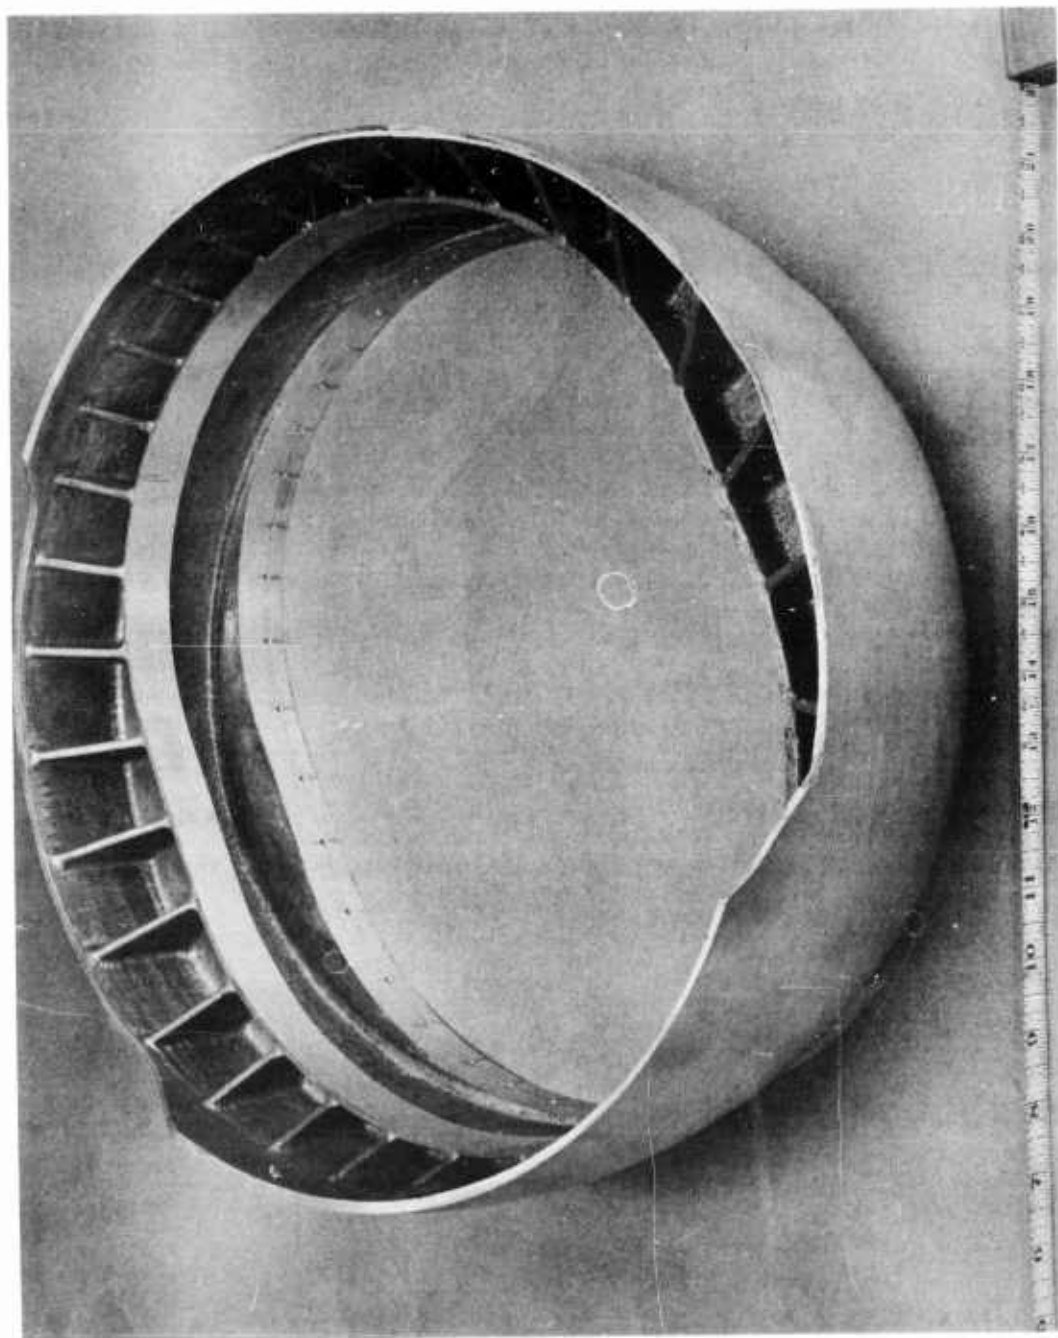
Figure 3.4-1. Blade Feathering - Flapping Bearing Ball, prior to honing and chrome plating

On each blade there is a feathering-flapping bearing consisting of all aluminum alloy ball (Figure 3.4-1) in contact with a teflon-faced outer race. Because of the complex internal configuration, the ball was cast. For wear resistance, the aluminum ball was chromium plated with a dense, moderately hard coating. On the ball of the initial test bearing, the chromium plate was applied directly to the aluminum surfaces without a base coat. After approximately one month exposure to outdoor atmospheric conditions, blisters were found on the upper surface. Examination revealed a typical aluminum corrosion beneath the chromium plating.

After the feathering balls were put into service on the Hot Cycle whirl test (18 hours of whirl, six months elapsed time within one mile of the Pacific Ocean), some blistering of the chromium plated surface was observed on two

bearings. No corrective action, however, was considered necessary at that time. At the end of a total of thirty-five hours testing (7-1/2 months total elapsed time), it was found that one ball showed no blistering, one had a very small amount in a non-critical region, while the third showed a considerable amount of blistering which approached a critical wear area. The blistering is shown on Figure 3.4-2. It was decided to replace the third ball.

In order to prevent this condition on parts for the whirl-test blades, an extensive investigation was conducted regarding the experience of platers and chrome-on-aluminum users. No experience could be found with chromium plating on cast materials, but considerable exposure has been accumulated for chromium plated directly on aluminum alloy forged bar stock, without a base coat, and used extensively on landing gears for fighter and bomber planes. Findings of the investigation led to the conclusion that casting porosity, and thoroughness of cleansing of the plating preparatory solutions were major factors in producing the corrosion and blisters. It was therefore decided to produce finer grained castings and to chrome plate directly on the aluminum as before, but with much more careful control of the process.

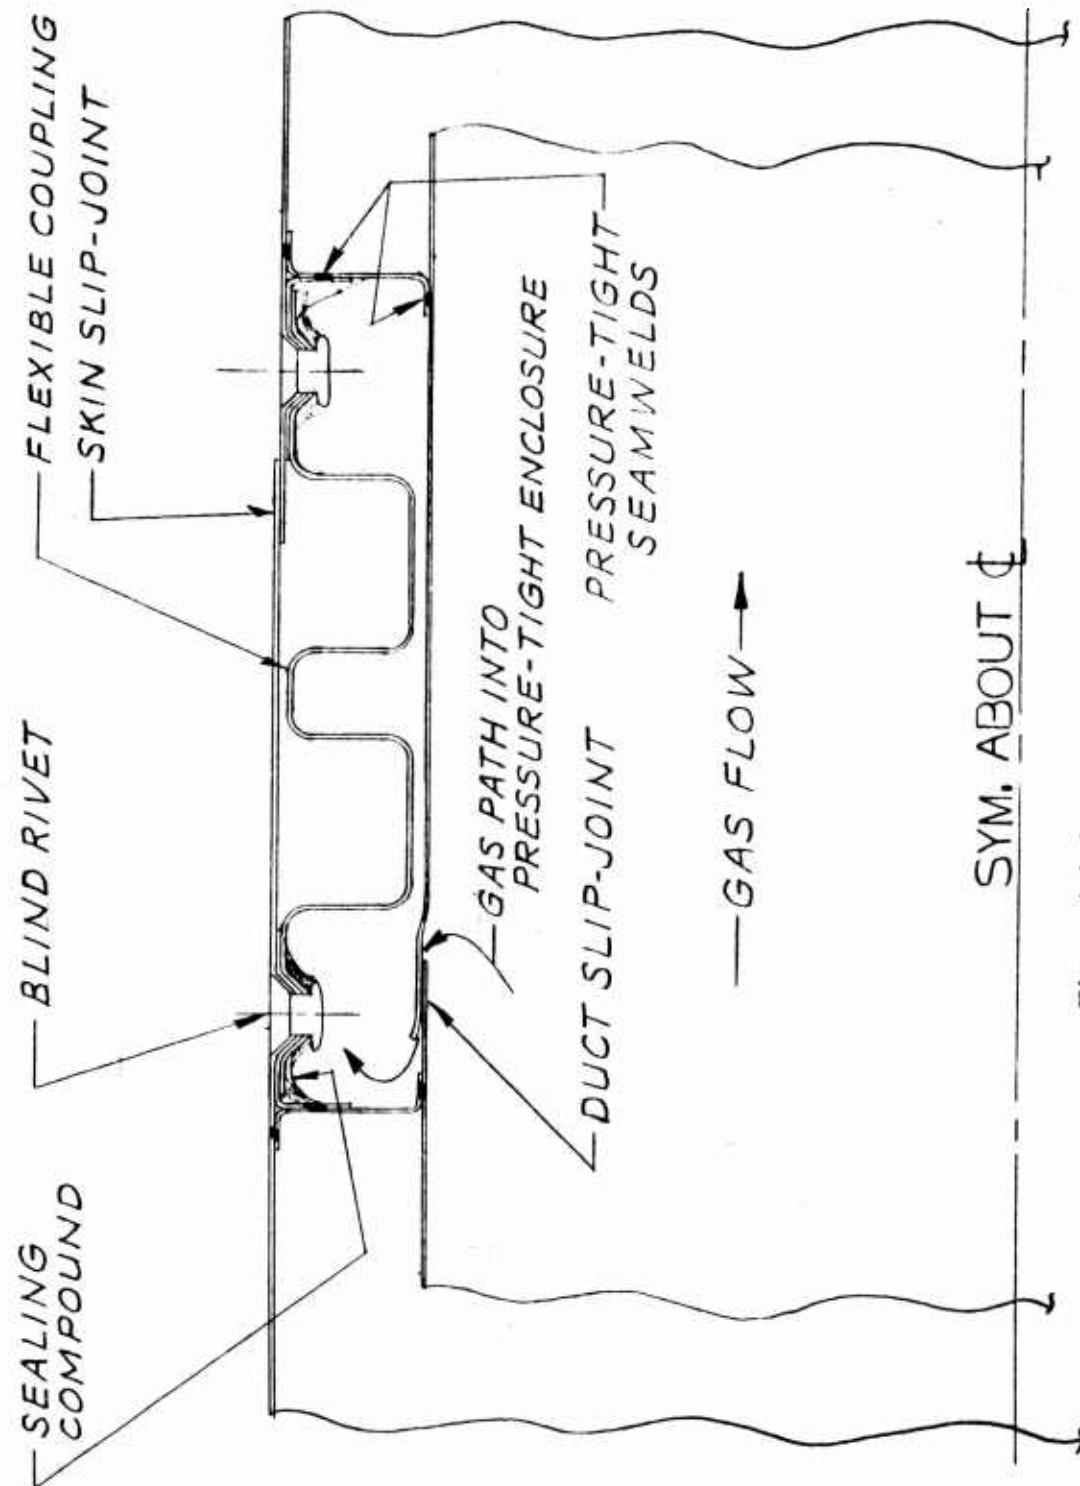
Figure 4.1-1  
Typical Blade Segment Joint

The Hot Cycle Rotor Blade consists of a series of one-foot long segments with two ducts suspended within the ribs. It was necessary to seal the segments at the flexure rib and skin joint (refer to Section 3 and to Figure 4.1-1) because sealing was not possible at the duct joints. It was originally expected that, with engine output limited to 900°F, the blade skin temperatures would not exceed 200°F. Many sealant materials were investigated including ceramic cements and various elastomeric materials. Silicones elastomers demonstrated superior flexibility, adhesion, and strength up to 500°F.

An intensive investigation and test revealed that a defective batch of primer had been furnished by Dow Corning which prevented adhesion of the compound. It was also found that because of the difficulty in drilling and

Because of the extensive rework involved in disassembling the blades, a repair was attempted by placing a bead of RTV601 Silicone over the existing material. Laboratory tests had indicated that by coating the existing silicone material with Dow Corning A 4094 Primer a satisfactorily cured seal could be produced. A pressure gun with a 1/8" O. D. tube attached was used through a rivet hole to lay the bead. This was by nature a blind operation and in several areas RTV601 Silicone was forced into the duct area, similar to that shown on the test specimen of Figure 4.1-2. This in turn created a question of the stability of RTV601 at 1100 to 1150°F.
